Manhole Inspection Summary

Manhole # S53C2_003MH

Location Address: **Northridge Ave.**

Cross Street: **Fairfield Rd.**

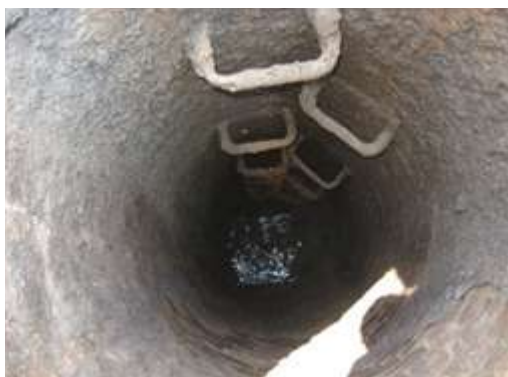
Steps Count: **18** Missing: **2** ☒ **Corroded**

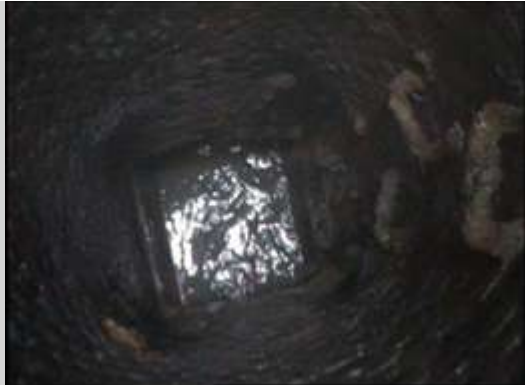
Pipe Out @ 12 O'Clock

Pipe Height: (in.) Rod and Bar (Angled)
Pipe Material: **Clay** ☐ Pipe Lined
Invert Depth: (ft.) Flow Characteristics: **Fast**
Deposits: ☒ None ☐ Mud ☐ Sludge ☐ Debris ☐ Grease
Silt Depth: (in.) Deposits Extent:
Infiltration: **None** Pipe Seal Cond: **Sound**

Drop: **None**

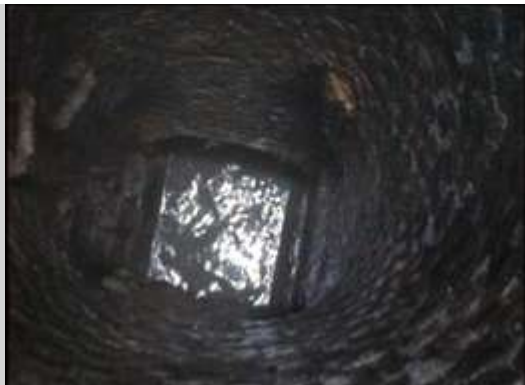
Pipe In @ 6 O'Clock

Pipe Height: (in.) Rod and Bar (Angled)
Pipe Material: **Clay** ☐ Pipe Lined
Invert Depth: (ft.) Flow Characteristics: **Fast**
Deposits: ☒ None ☐ Mud ☐ Sludge ☐ Debris ☐ Grease
Silt Depth: (in.) Deposits Extent:
Infiltration: **None** Pipe Seal Cond: **Sound**

Drop: **None**
